# SMS Accident Decomposition

May 5, 2011

# Decomposition of Aviation Accident to Clarify SRM and SA functions

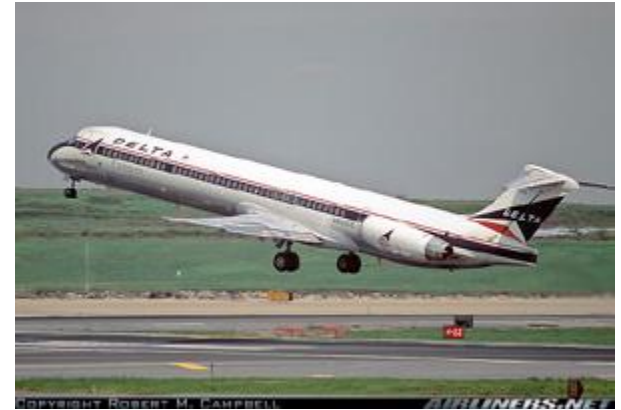
- NTSB DCA96MA068
- July 6, 1996
- Uncontained Engine Failure, Delta MD-88 (engine debris from the front compressor front hub (fan hub) of the No. 1 (left) engine penetrated the left aft fuselage. Two passengers killed and two others seriously injured. The takeoff was rejected, and the airplane was stopped on the runway.
- Features
  - Significant D&M Issues
  - Major Investigation (i.e., significant time and expense)
  - 30 findings and 15 related recommendations
